## AZ1L Direct-View LCD Television Chassis

### Circuit Description and Troubleshooting Guide

MODELS:     KDL22EX308  
               KDL32EX308

**Course : CTV-68**

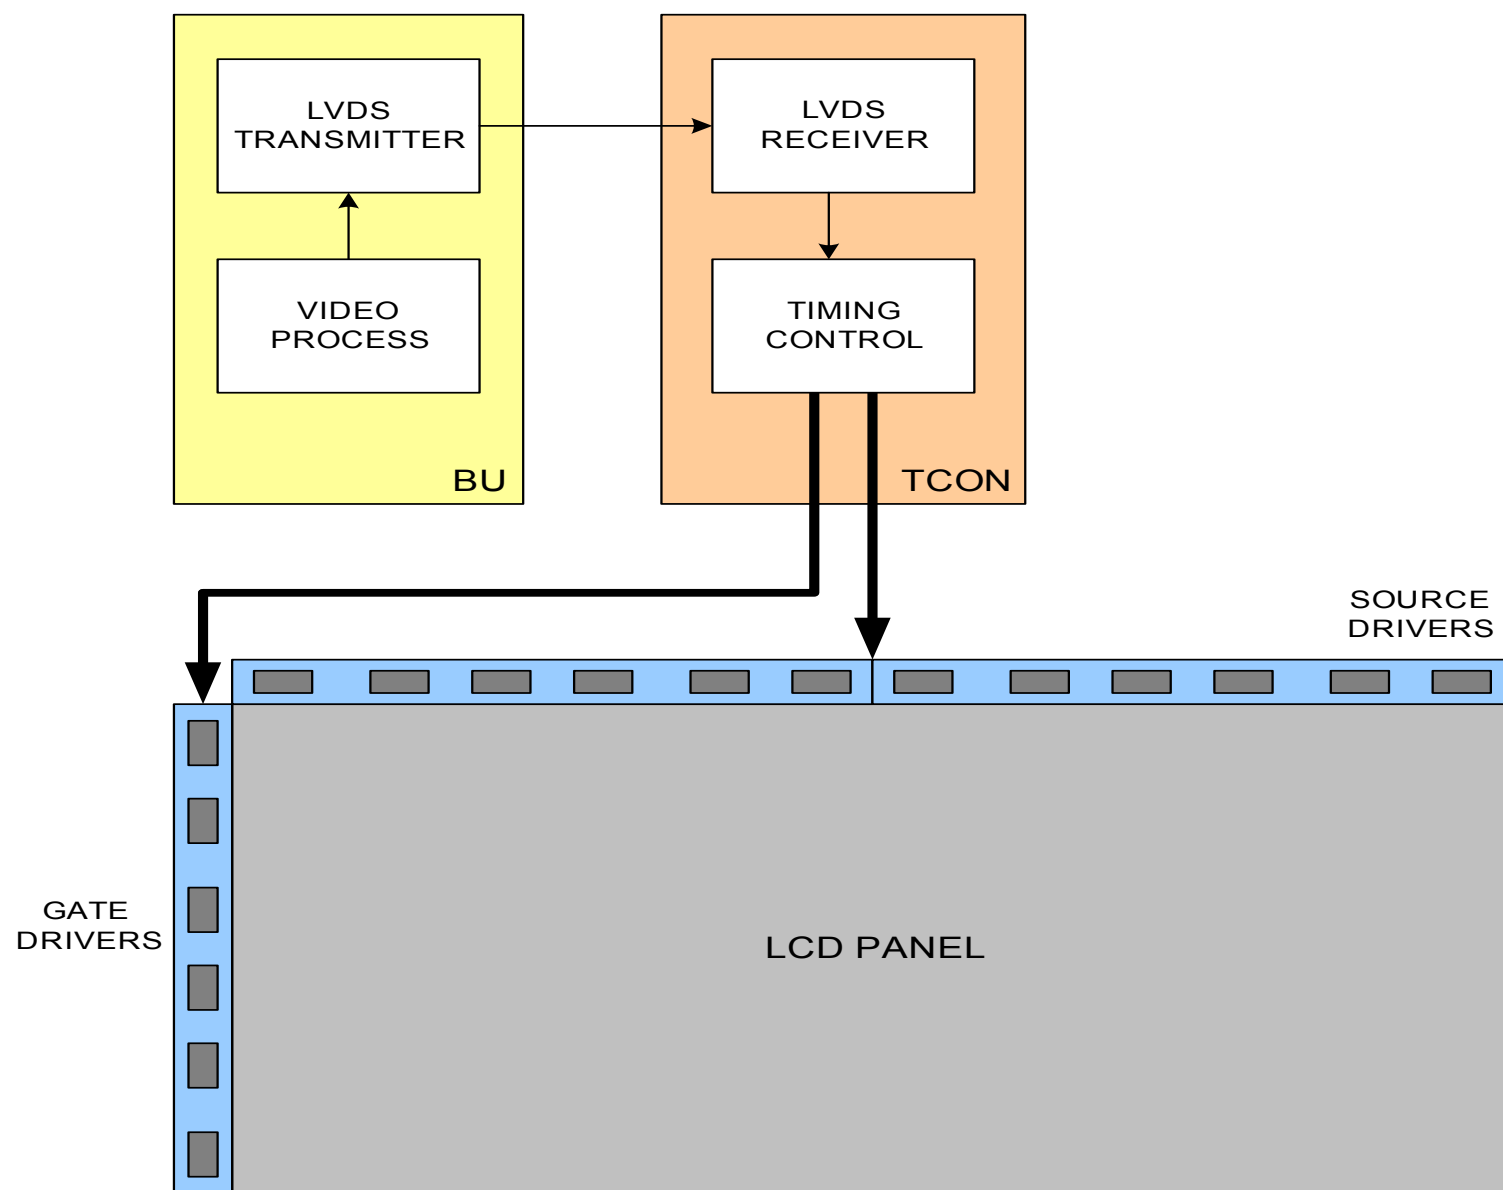
FIGURE 4-1  
TYPICAL LCD TIMING CONTROL

Figure 4-1 illustrates a typical LCD panel and the associated video processing circuits as found in the WAX3 chassis. The various formats and resolutions of video signals are processed on the BU1 board. All video signals exit the video processor in the native resolution of the LCD panel. In this design, the resolution is for a 1366 by 768 at 60HZ refresh rate panel. 48 horizontal lines are discarded to match up to the 720p resolution of the ATSC specifications so the video will exit as 720p.

Referring to Figure 4-1, note the IC's located along the side of the panel. These IC's are mounted on a flexible cable(s) which are bonded to the LCD panel. Their function is to activate each row of pixels one at a time starting with the first line at the top. As each line is activated, the source drivers turn on the appropriate liquid crystals for the frame of video about to be displayed. This continues from top to bottom until the entire frame of video is displayed. The process is repeated for the next frame. This rate can vary from 60 times per second or be increased to 120 or 240 as found in the high-frame-rate panels.

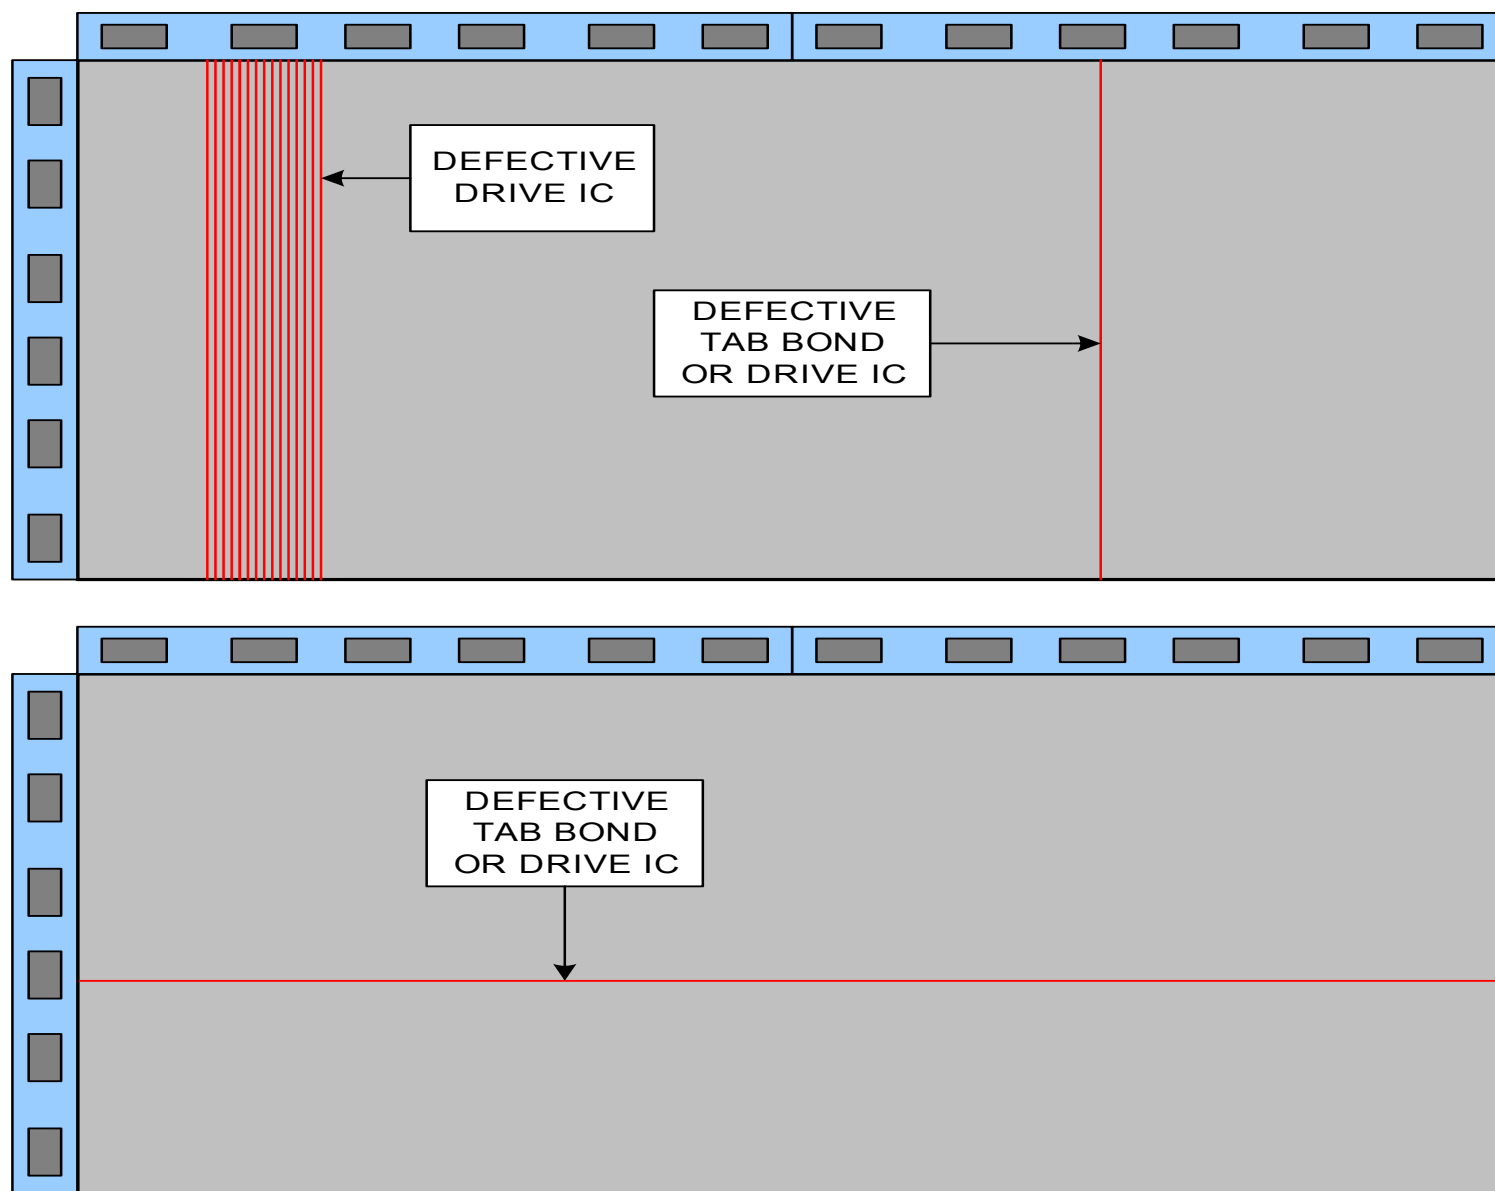
FIGURE 4-2  
TYPICAL LCD PANEL FAILURES

**LCD Panel Failures:** Some LCD panel failures could possibly be mistaken for TCON issues. Other than damage to the LCD glass, most panel failures are isolated to a particular area of the screen. Since the TCON disperses the pixel data to groups of line and column drive IC's situated on the outer edges of the panel, it is unlikely that more than one of these IC's would fail at the same time. Multiple columns of stuck on or stuck off pixels are, therefore, more likely to be the fault of the TCON circuits. The same applies to a single row of lit or unlit pixels. The TCON simply cannot cut out a single line of information. Figure 4-2 illustrates some typical symptoms of failures that are caused by the LCD panel.

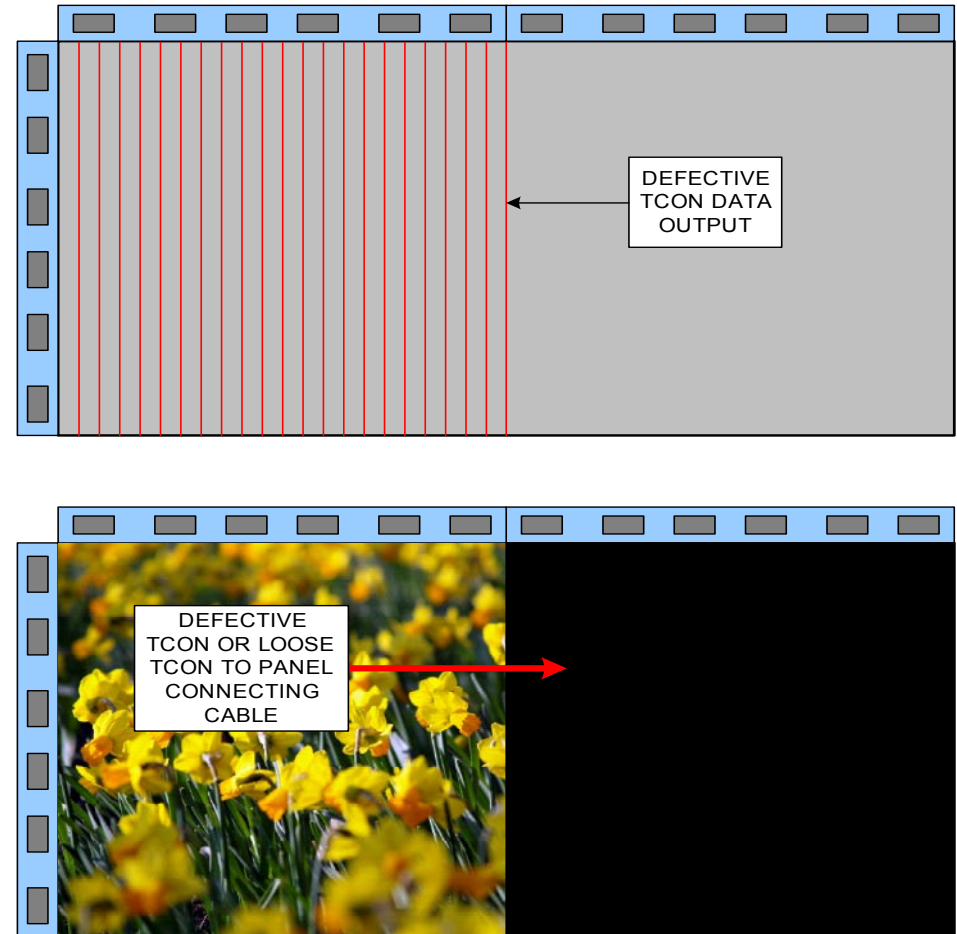
FIGURE 4-3  
LCD TIMING CONTROL FAILURES

One trick to check most TCONS for functionality is to loosen the LVDS connector at the TCON (as shown In Figure 4-3) while the unit is turned on. Handle the LVDS connector with care and be certain to fully release the lock tabs. Gently rock the cable in and out of the connector while observing the screen for any response. Depending on the chassis, the symptoms of the screen may be gentle white flashes, intermittent colored lines, or a screen full of random patterns. The idea at this point is to provoke some kind of response on the screen. TCON boards that have failed will not usually generate any type of response on the screen.

Figure 4-3 illustrates 2 examples of a loss of control data to the drive IC's. In the first example, an entire group of column drivers has lost the data stream for red. The second example involves the complete loss of drive data for all RGB information to the right side of the screen. This is sometimes caused by the flat cable connecting the TCON to the LCD panel coming loose. The area of missing video can be dark or completely white depending on the panel design.

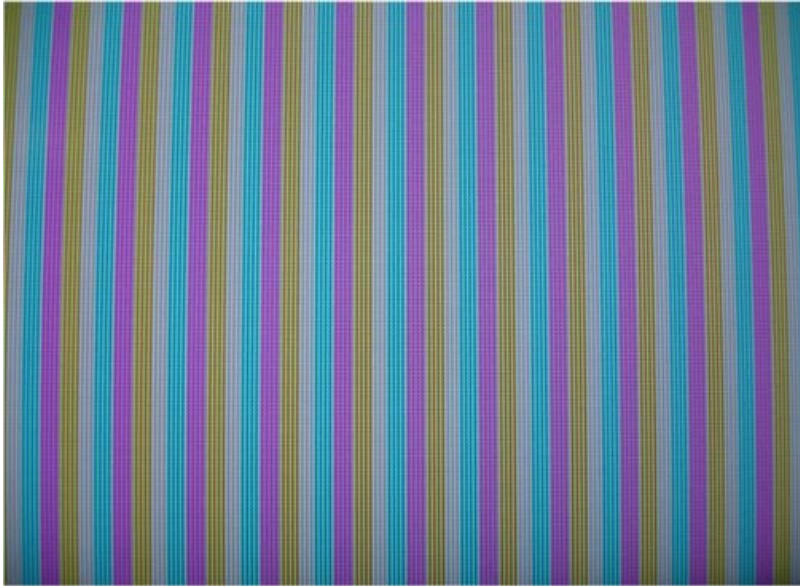
REPETATIVE STAIONARY LINES

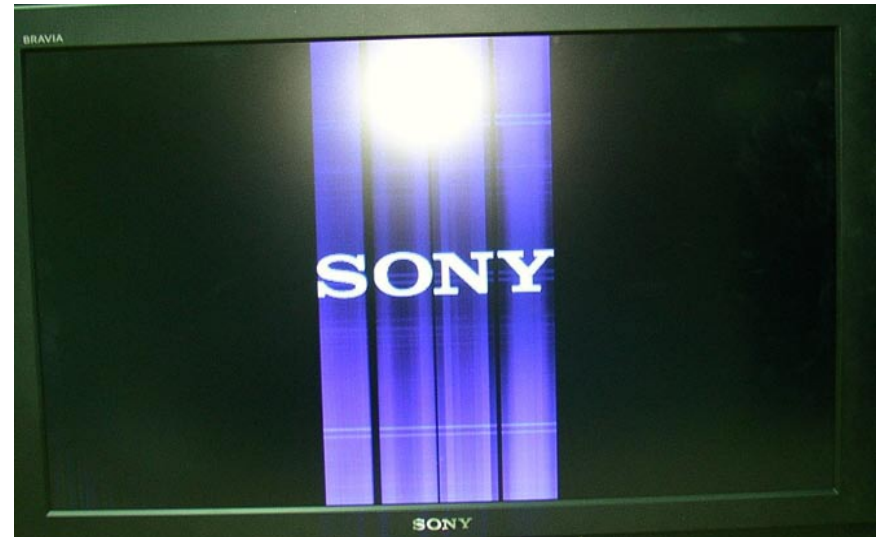
MULTIPLE SOURCE DRIVE IC FAILURE

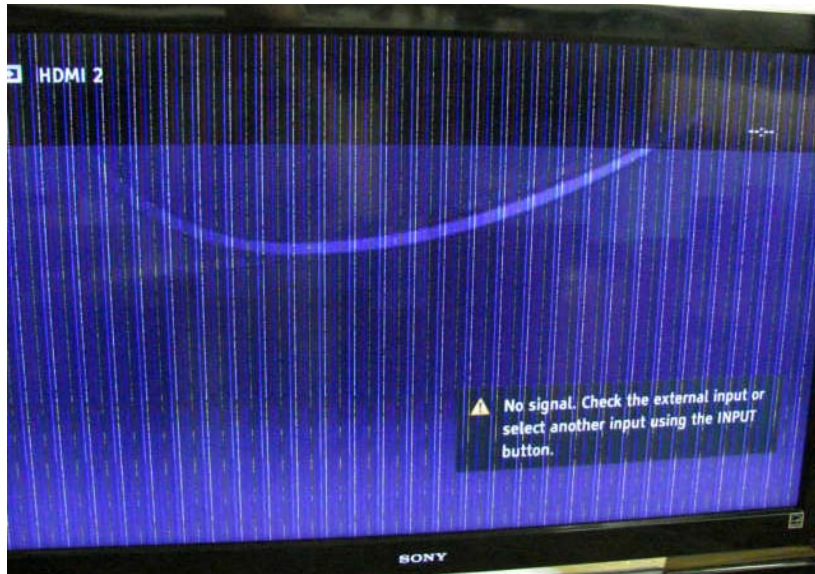
MULTIPLE EVENLY SPACED LINES NOT AFFECTED BY PICTURE ZOOMING

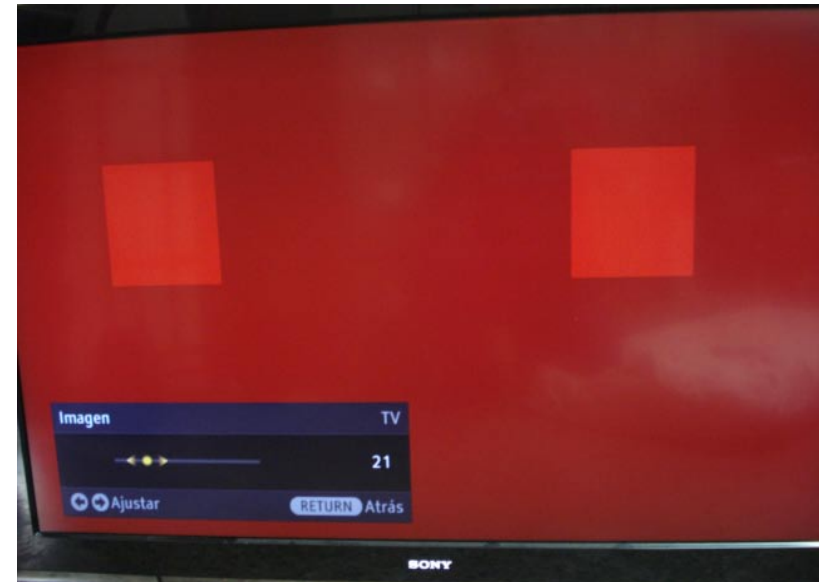
SYMETRICAL RED BOXES

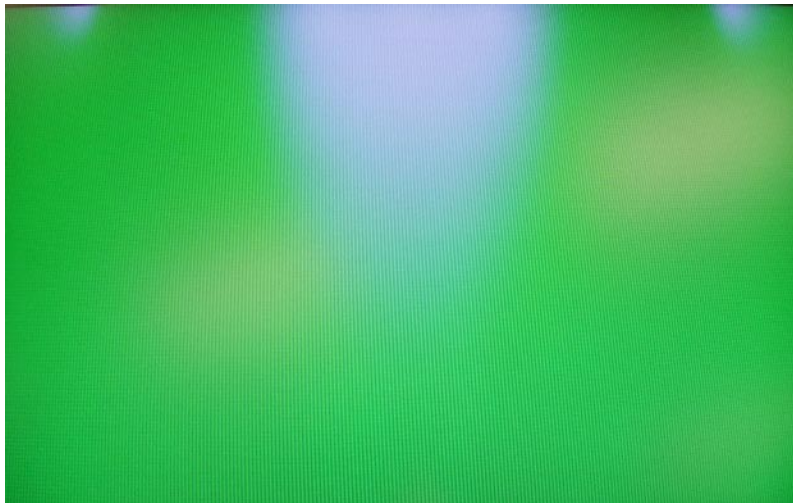
LOADED SOURCE DRIVE DATA LINE

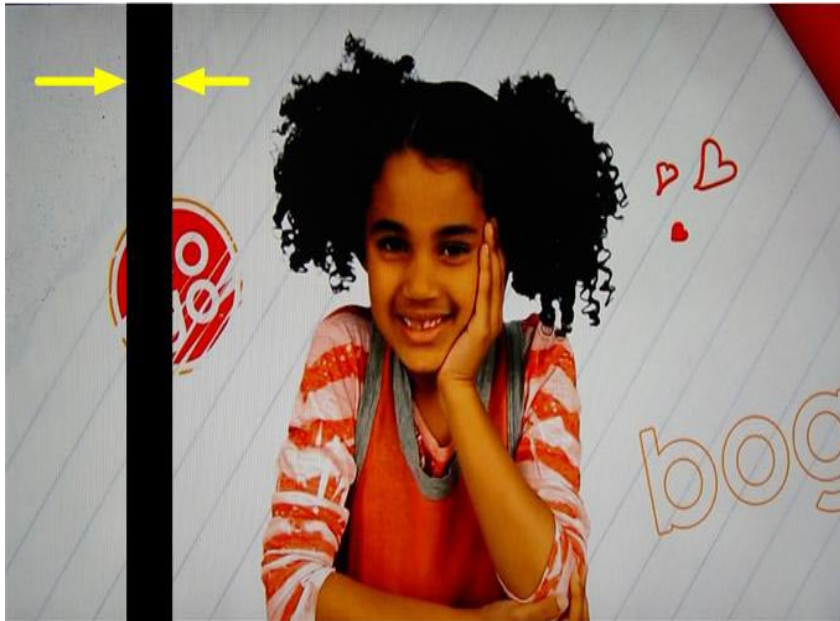
SOURCE DRIVE IC FAILURE

Below are some photos of actual LCD panel failures. Note that most issues tend to be isolated to a certain area of the screen with the exception of failures of the source drivers. The source drivers can cause thin horizontal line issues and can also affect a large area of the screen.

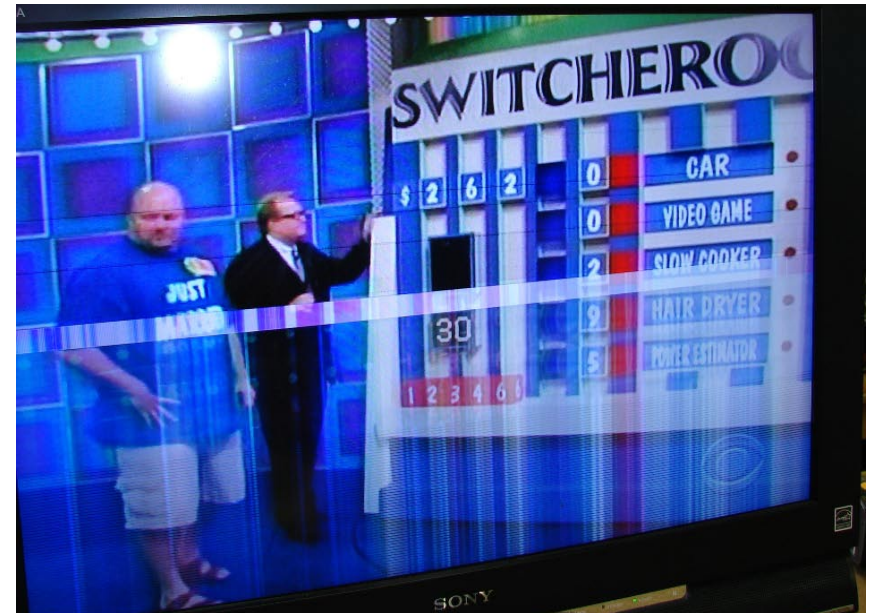
GATE DRIVER FAILURE

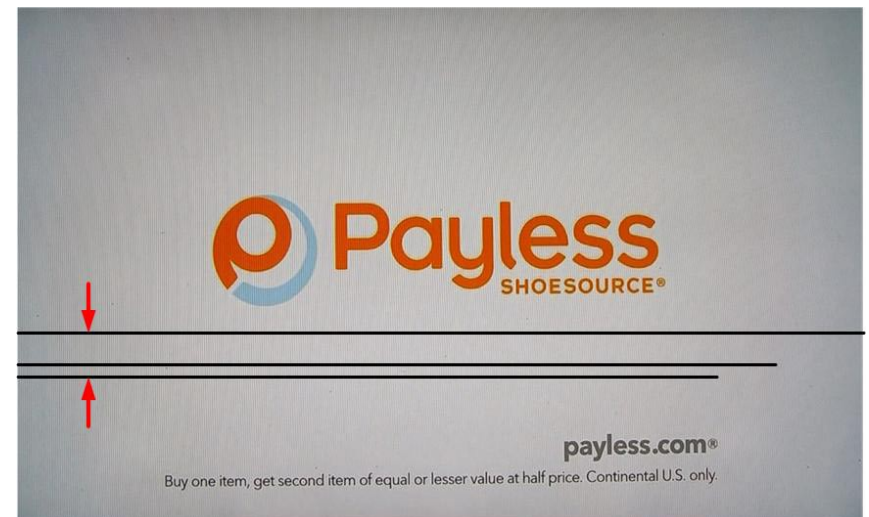
GATE TAB BOND FAILURE

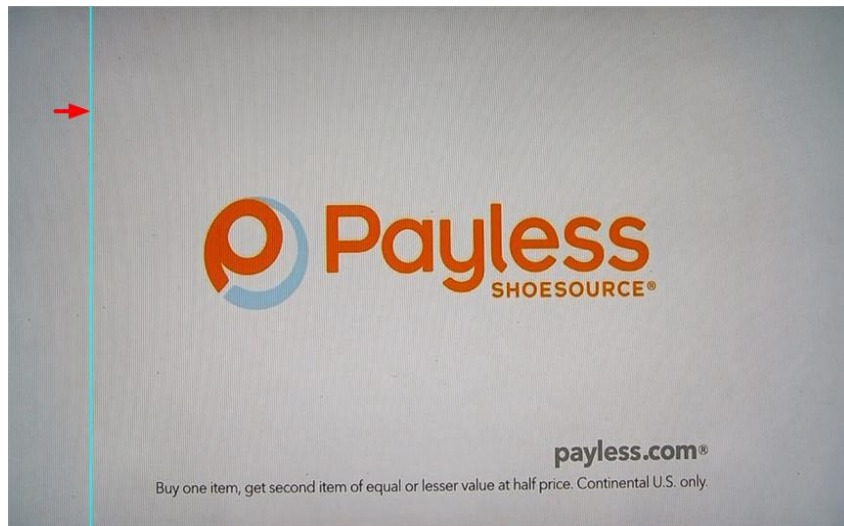
SOURCE TAB BOND FAILURE

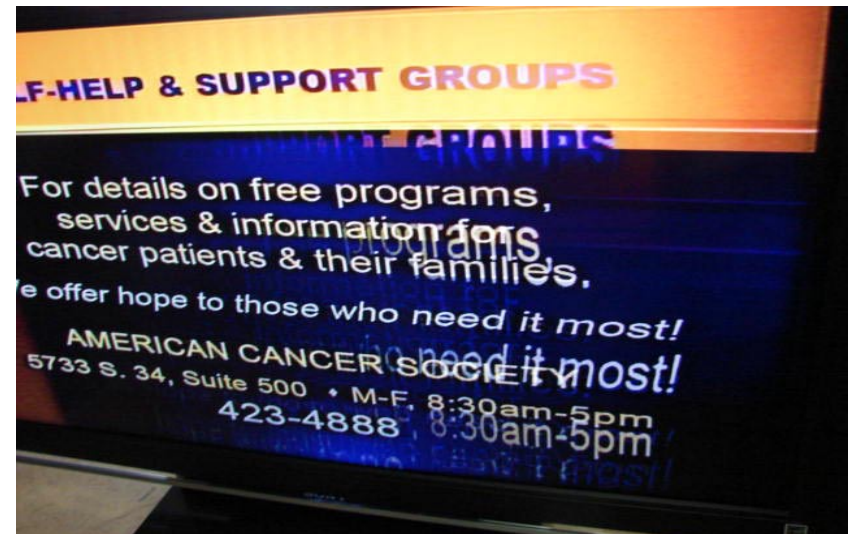
GATE TAB BOND FAILURE

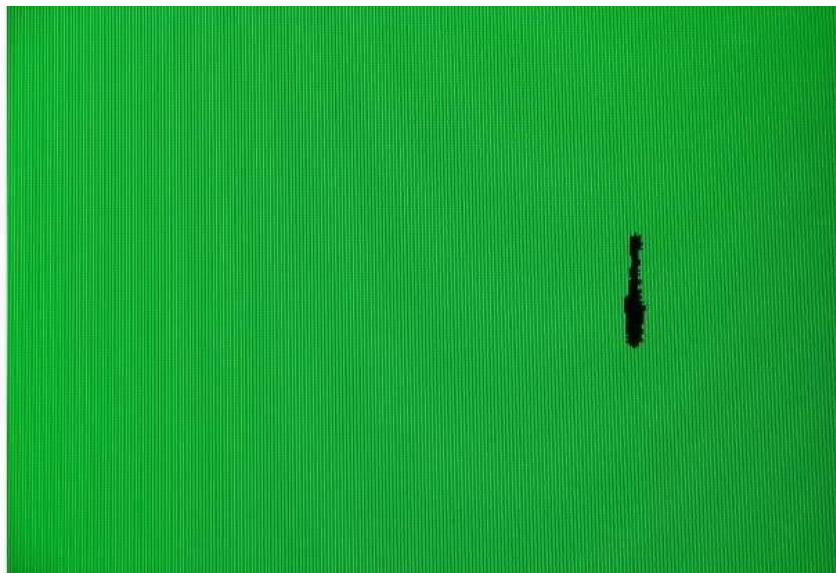
MULTIPLE PIXEL FAILURE

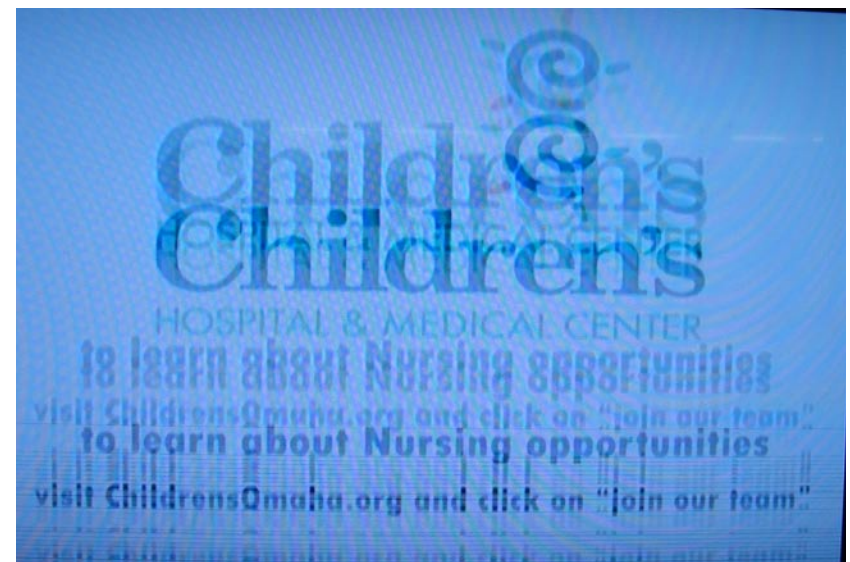
GATE TAB BOND FAILURE
